# Check-out Inventory Report

House A Sample Street, Sample Road,  
Sample, Jersey, JE2 7HB

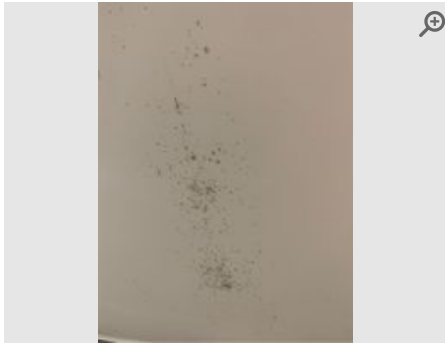
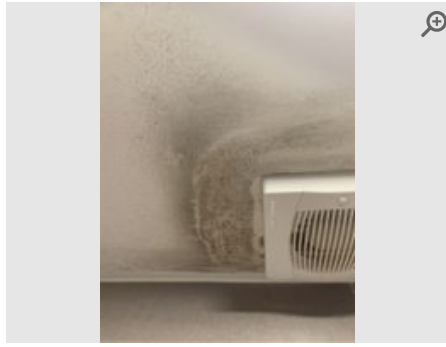
| Reference | <b>12.2.1</b> |

| Name | Status |
|---|---|
| Ceiling | Clean |

This 4 bedroom property is in good condition and cleanliness throughout with exception of the ceiling in the ensuite in bedroom 3; Marks and mould present, due to lack of ventilation.
