# Check-out Inventory Report

House A Sample Street, Sample Road,  
Sample, Jersey, JE2 7HB

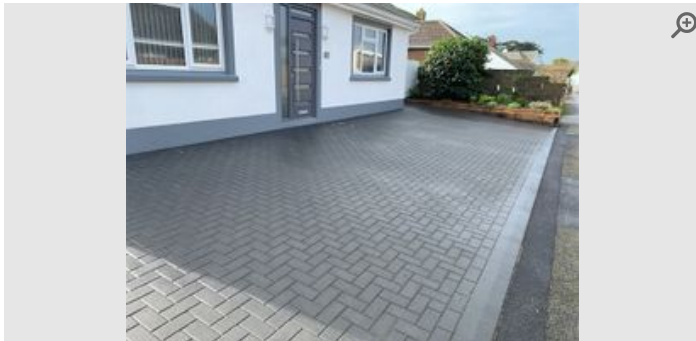
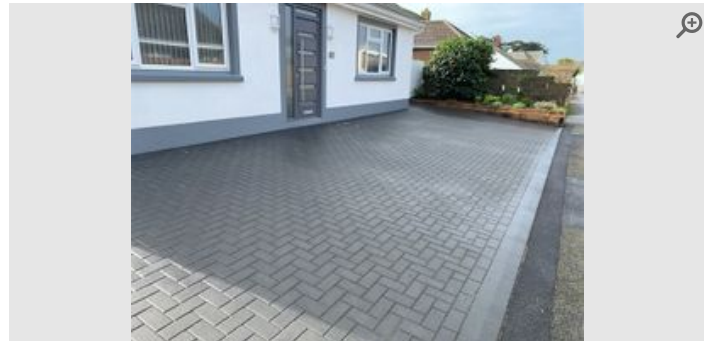
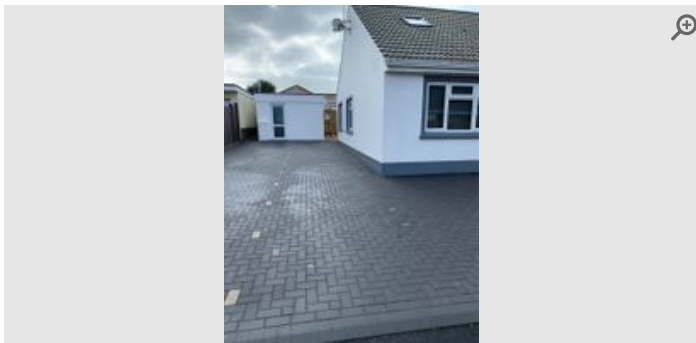
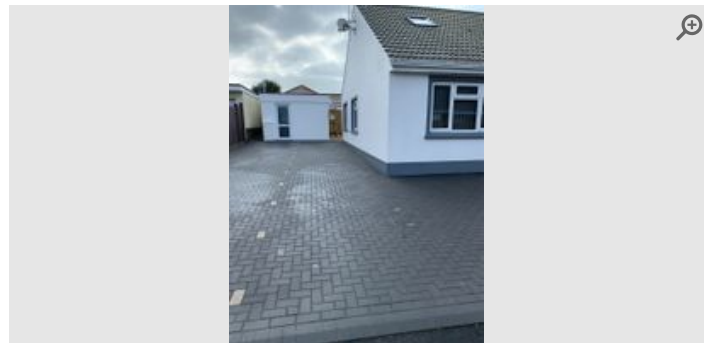
| Item | Date | Description | Condition | Cleanliness | Photos |
|---|---|---|---|---|---|
| Overview<br>(Parking Space)<br>15.1 | Previous State<br>2nd February 2021 | Paved area. Clear allocated markings. Free of oil/paint stains | ● New Item | ● Excellent | 📷 2 photos |
| | Current State<br>27th February 2021 | Paved area. Clear allocated markings. Free of oil/paint stains | ● Good | ● Good | 📷 2 photos |

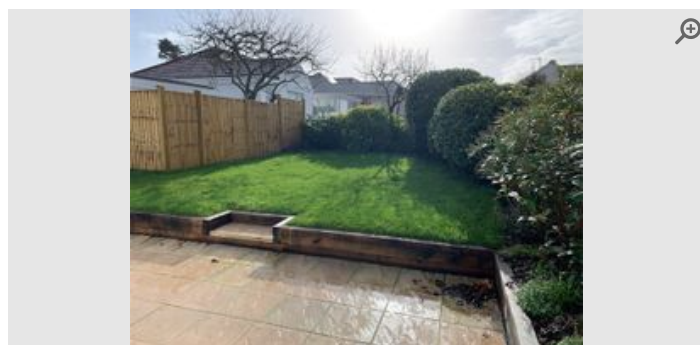
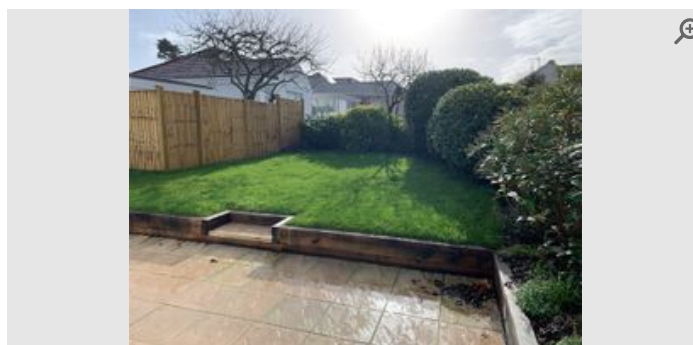
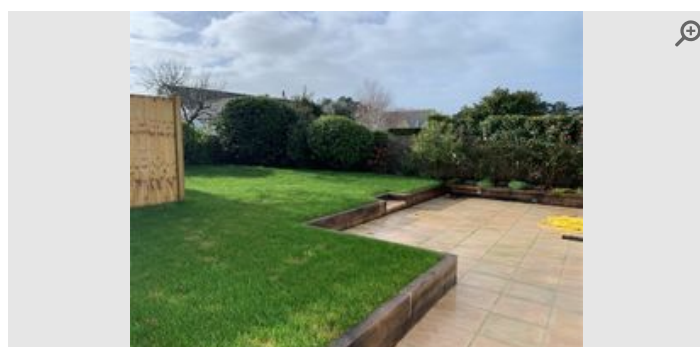
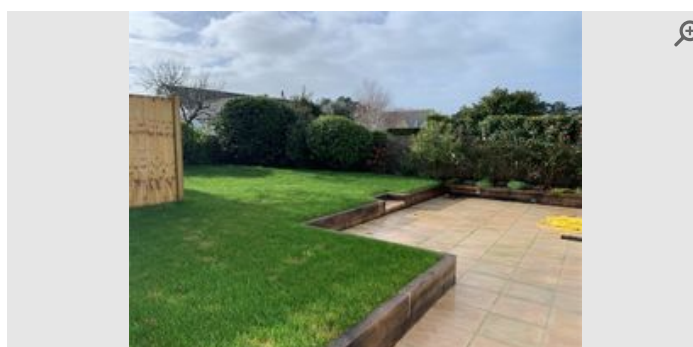
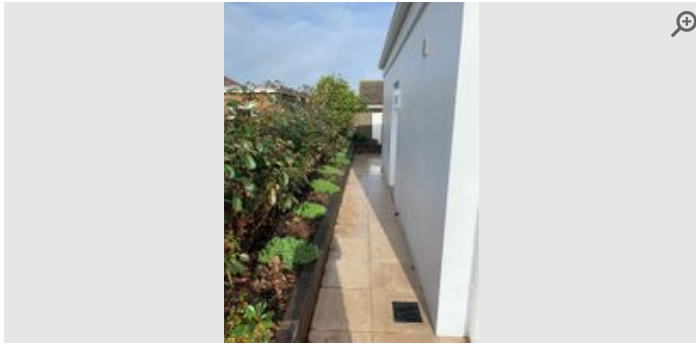
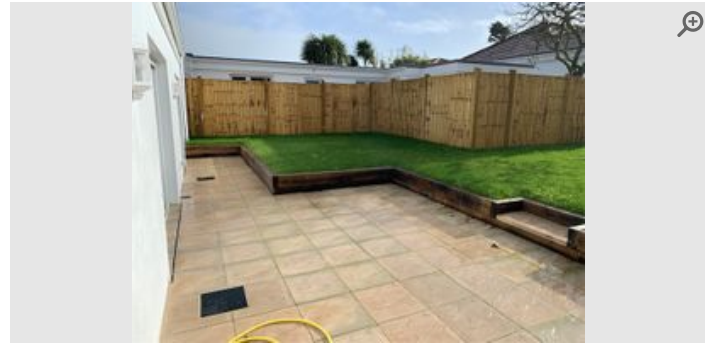
| Item | Date | Description | Condition | Cleanliness | Photos |
|---|---|---|---|---|---|
| Overview<br>(External)<br>16.1 | Previous State<br>2nd February 2021 | Fair seasonal order<br>Raised lawned area via wooden sleepers. Slabbed patio, free from cracks and no gaps to grouting. Mature shrubs and trees present. Side path raised beds covered with bark chippings. Fences appear securely fitted. | ● New Item | ● Excellent | 📷 6 photos |
| | Current State<br>27th February 2021 | Fair seasonal order<br>Raised lawned area via wooden sleepers. Slabbed patio, free from cracks and no gaps to grouting. Mature shrubs and trees present. Side path raised beds covered with bark chippings. Fences appear securely fitted. | ● Good | ● Good | 📷 5 photos |
